U.S. Fish & Wildlife Service

Underground fuel release at Midway Atoll:

02/18/2003 Update

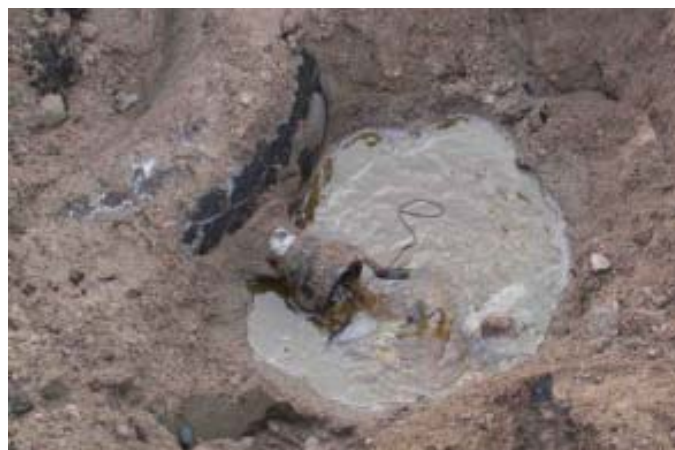
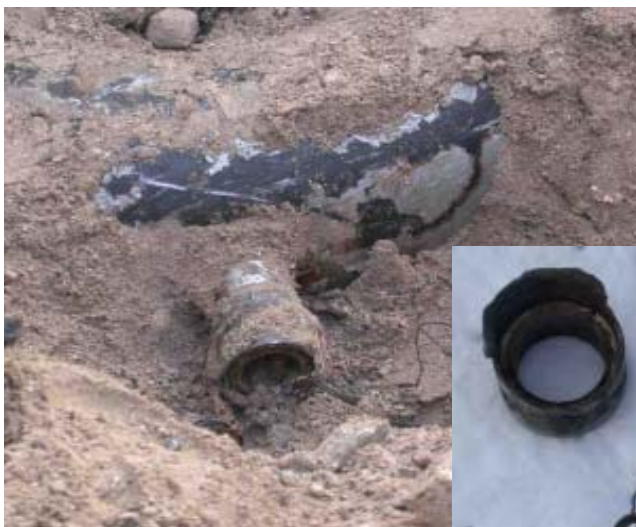
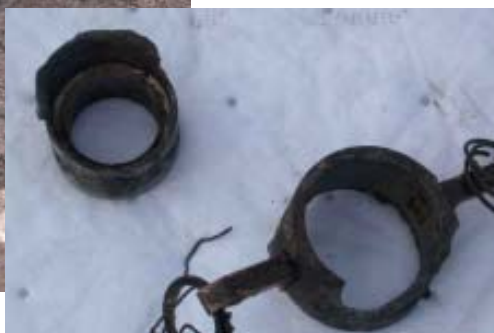
02/06: After confirming two contracted employees were certified to work in the hazardous materials site, an old concrete vault was excavated about 2' below the surface.

Inside the vault was an 8" fuel line and a 2" steel nipple, capped with an aluminum camlock fitting. The camlock fitting was badly corroded. Opening the valve allowed fuel to flow from the nipple.

Through a detailed review of fuel farm records, GeoEngineers, Inc., has determined that approximately 100,000 gallons of JP-5 were released through the corroded fitting.

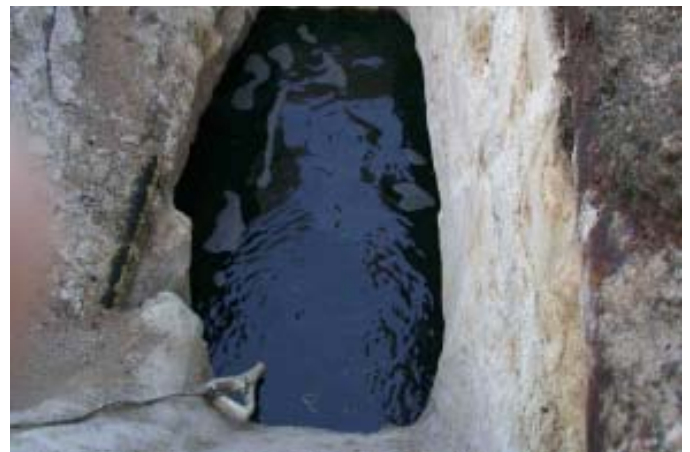
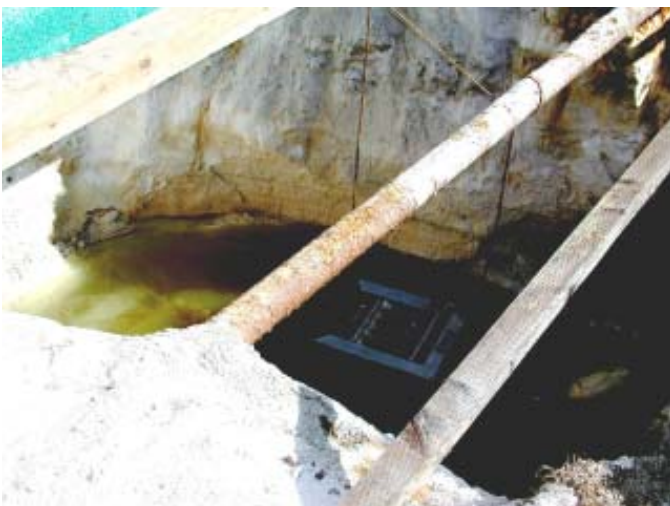
02/07-02/18: A U.S. Coast Guard flight on February 7 brought more resources to the project. Employees from Pacific Environmental Corporation and GeoEngineers and the Fish and Wildlife Service's Regional Environmental Compliance Specialist arrived on Midway to begin extracting fuel from the water table about 8' below the ground surface. Two extraction pits were dug. A mixture of water, JP-5 fuel, and heavy black oil began flowing into one pit, the other pit contains mostly JP-5 fuel.

A skimmer is being used in the extraction pit where the JP-5 and black oil is located. JP-5 fuel from the other extraction pit is being pumped out. The fuel mixture is pumped into an empty Mogas truck, where sand is allowed to settle to the bottom. The fuel mixture is then being transferred into fuel farm tank #30, where it will be stored until it can be transported to a recycling facility in Honolulu. Some of the JP-5 fuel may be recoverable for use in the generators on Midway. As of February 18, approximately 20,000 gallons of the fuel had been recovered.
